# Introduction to the Rail Sector Bill Free – Rail Director, CECA

CECA NW'S FOUNDATIONS GROUP AND LJMU CIVIL & STRUCTURAL ENGINEERING DEPARTMENT

12 February 2020

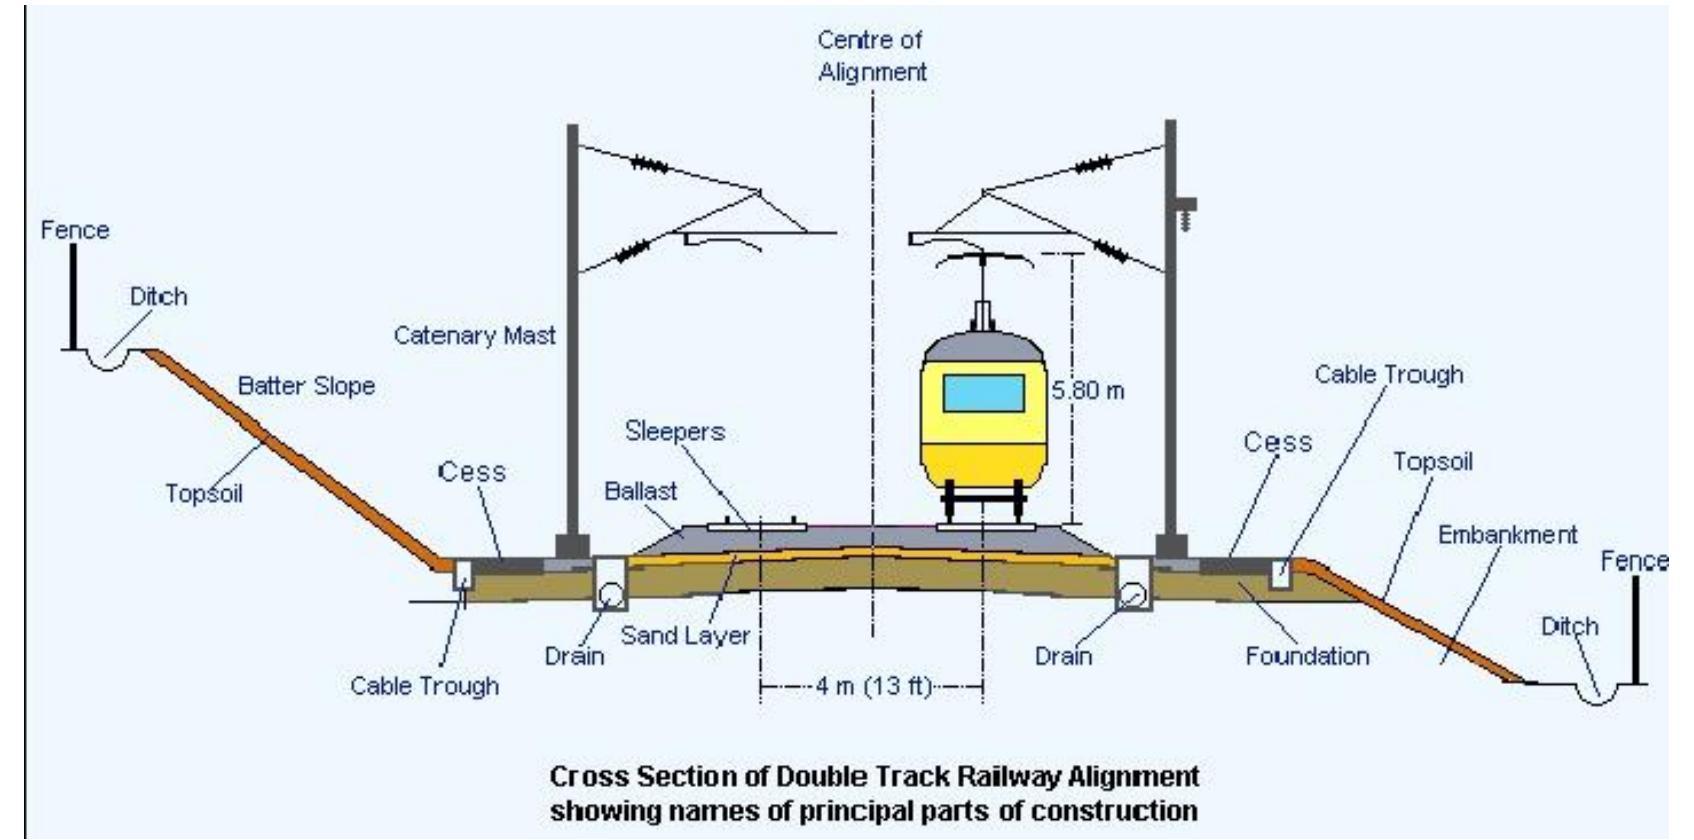
- Cross sections not unlike highways
- Cuttings deeper & embankments higher than historic roads
- Issues with:
  - Buried services
  - Inadequate & neglected drainage
  - Vegetation
  - Over steep slopes

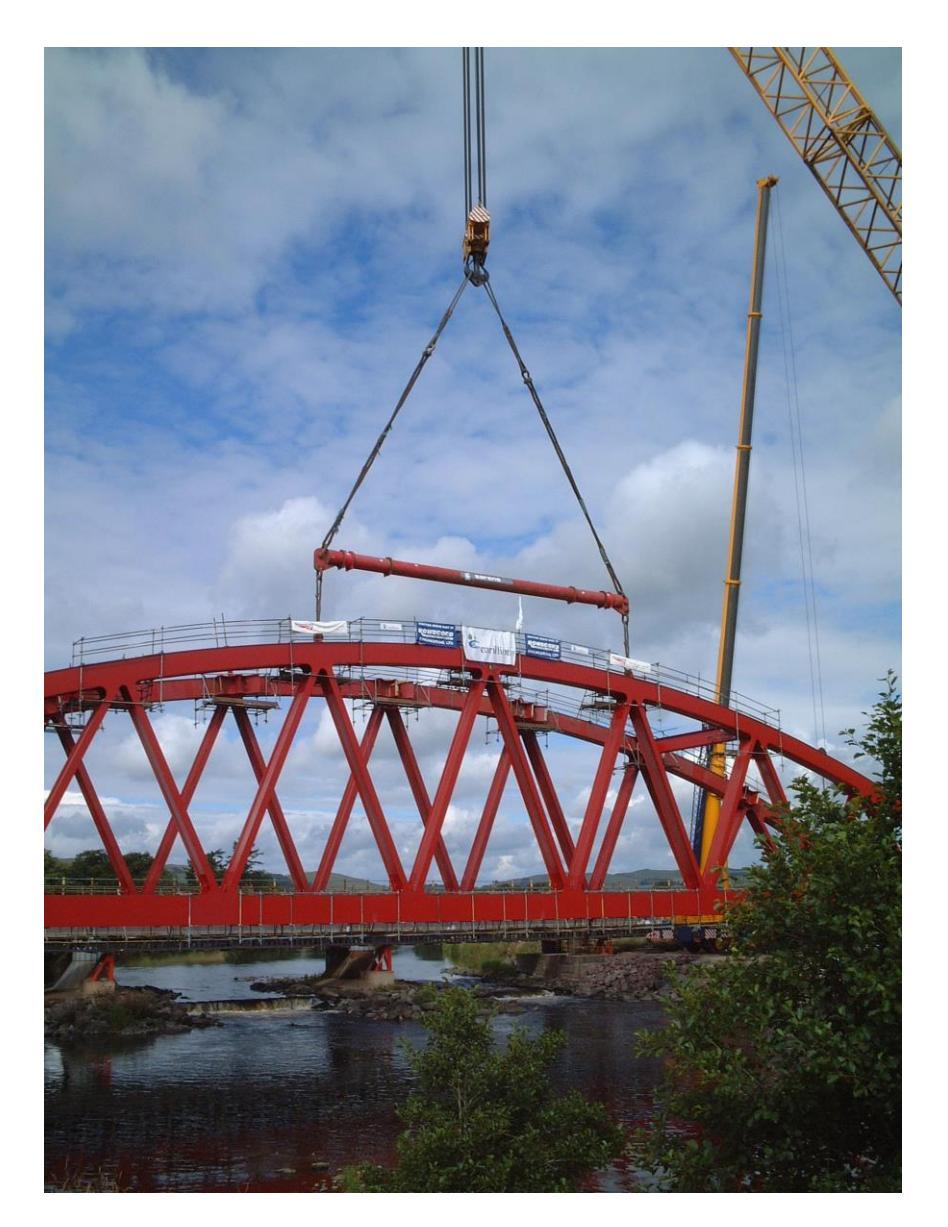
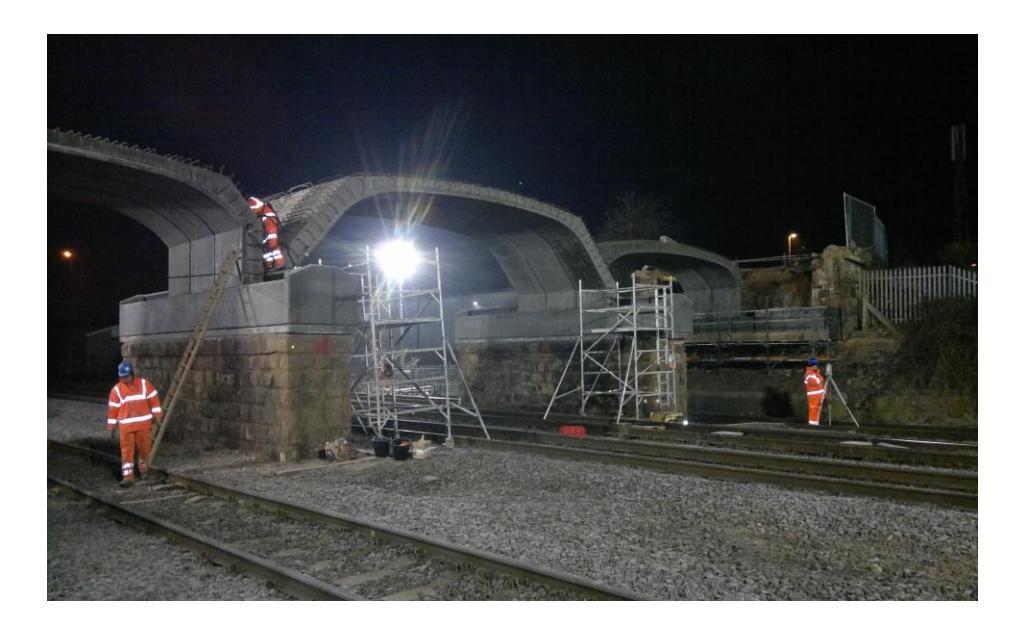
- Repairing / replacing failed structures bridges & retaining walls
- Increasing clearances for electrification and larger gauge trains
- Structures designed for rapid installation during railway possessions

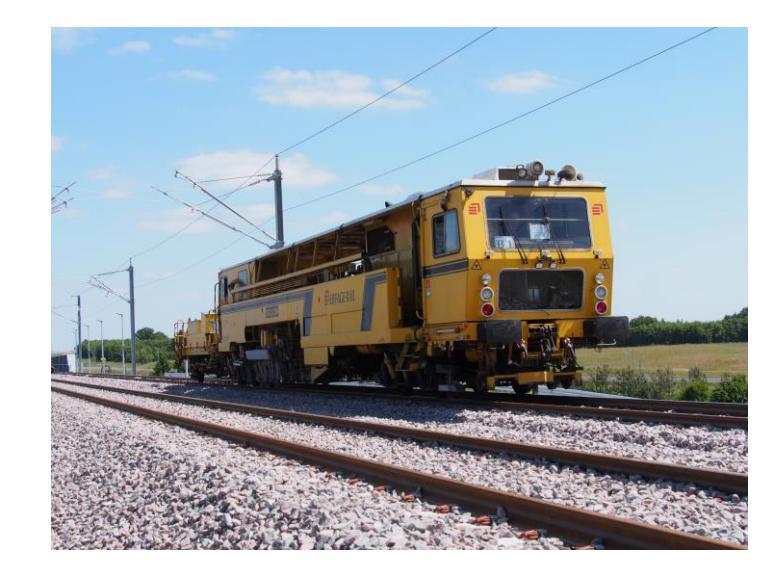
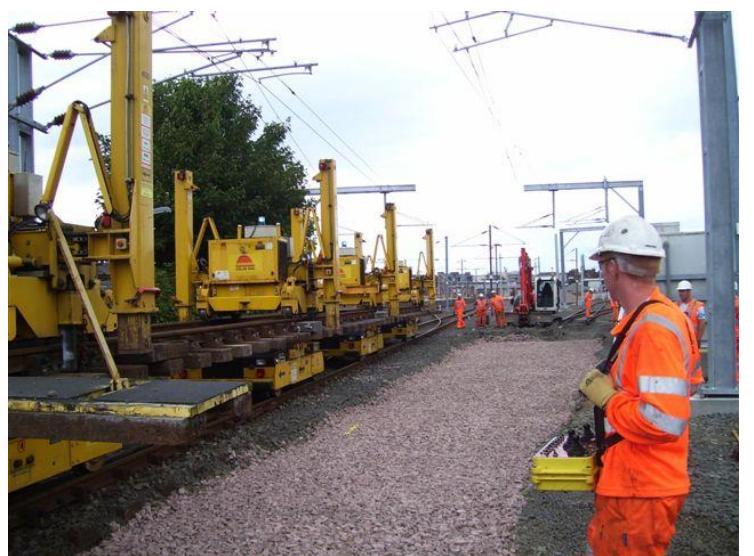
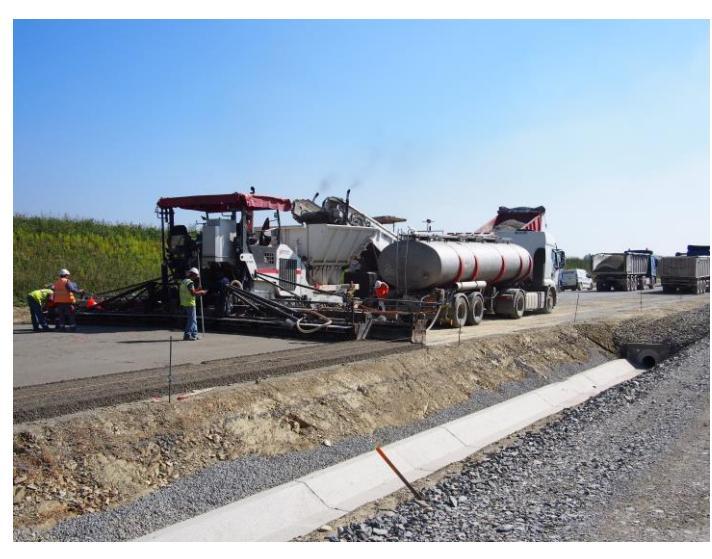
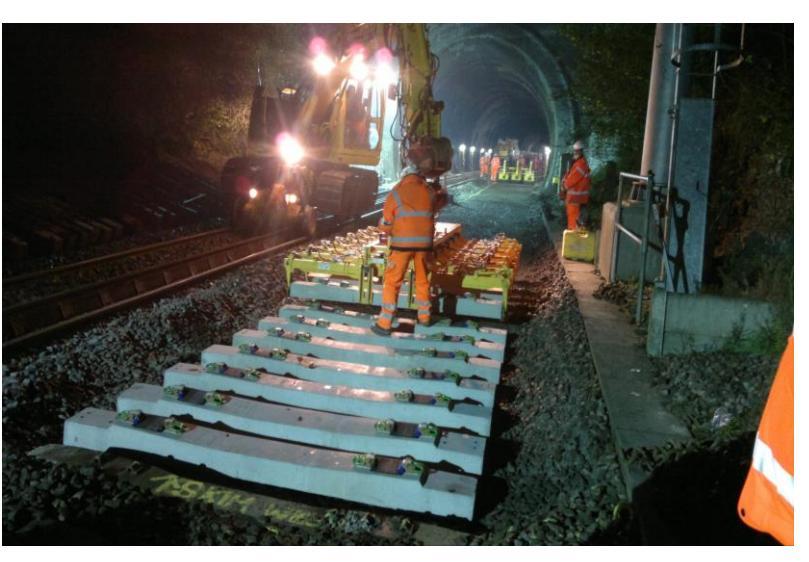
- Alignment is critical
- A lot of subgrade issues, due to age of assets
- Ballast and rails deteriorate reasonably quickly / slab track very critical wrt subgrade
- High tech solutions for track laying and maintenance
- Modern track has a very carefully prepared subgrade

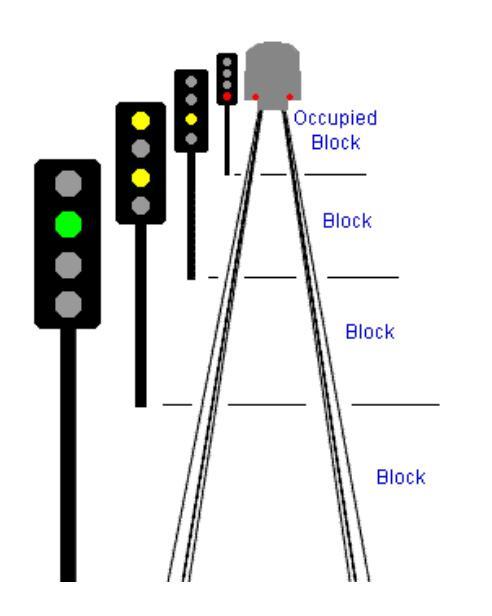
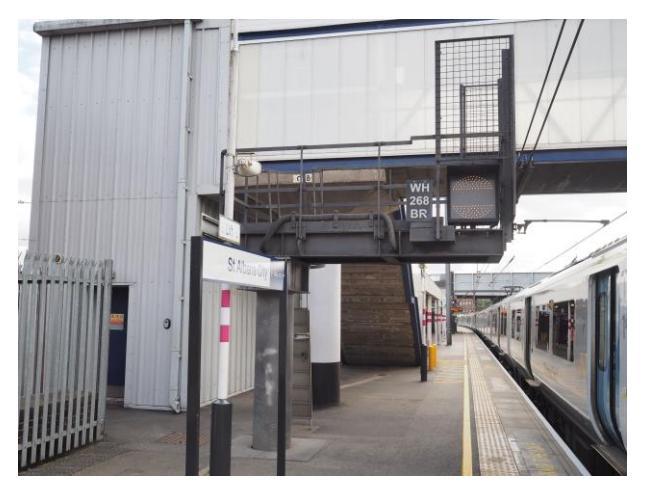
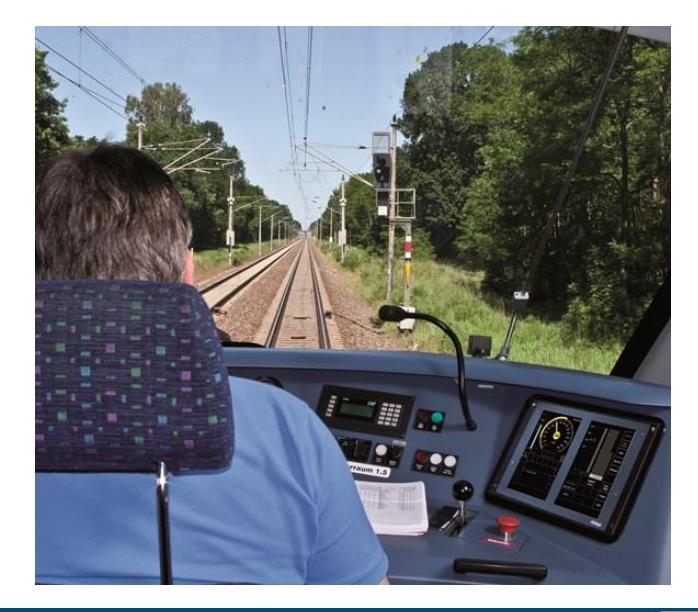
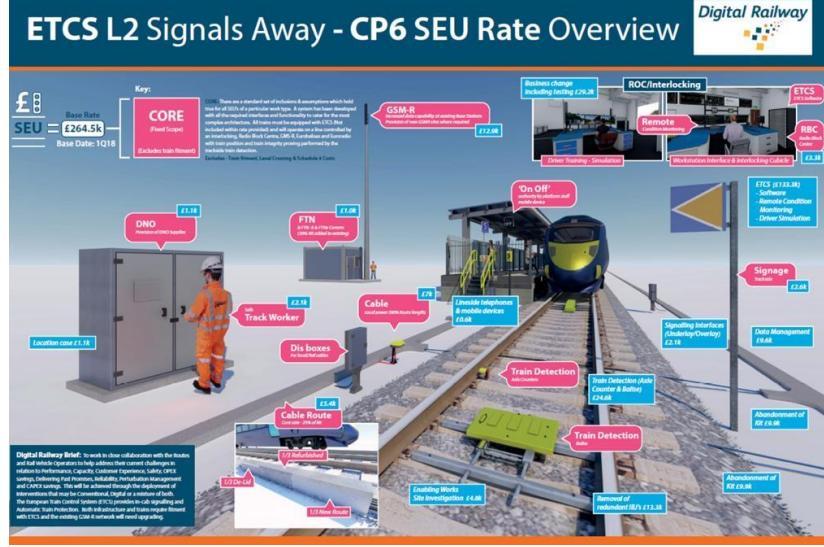
- A control system for trains using principles established in the earliest days of the railway
- Now mostly colour light signals, but still some semaphore systems surviving
- "Digital Rail" will bring in cab signalling and closer / faster running and "Traffic Management"

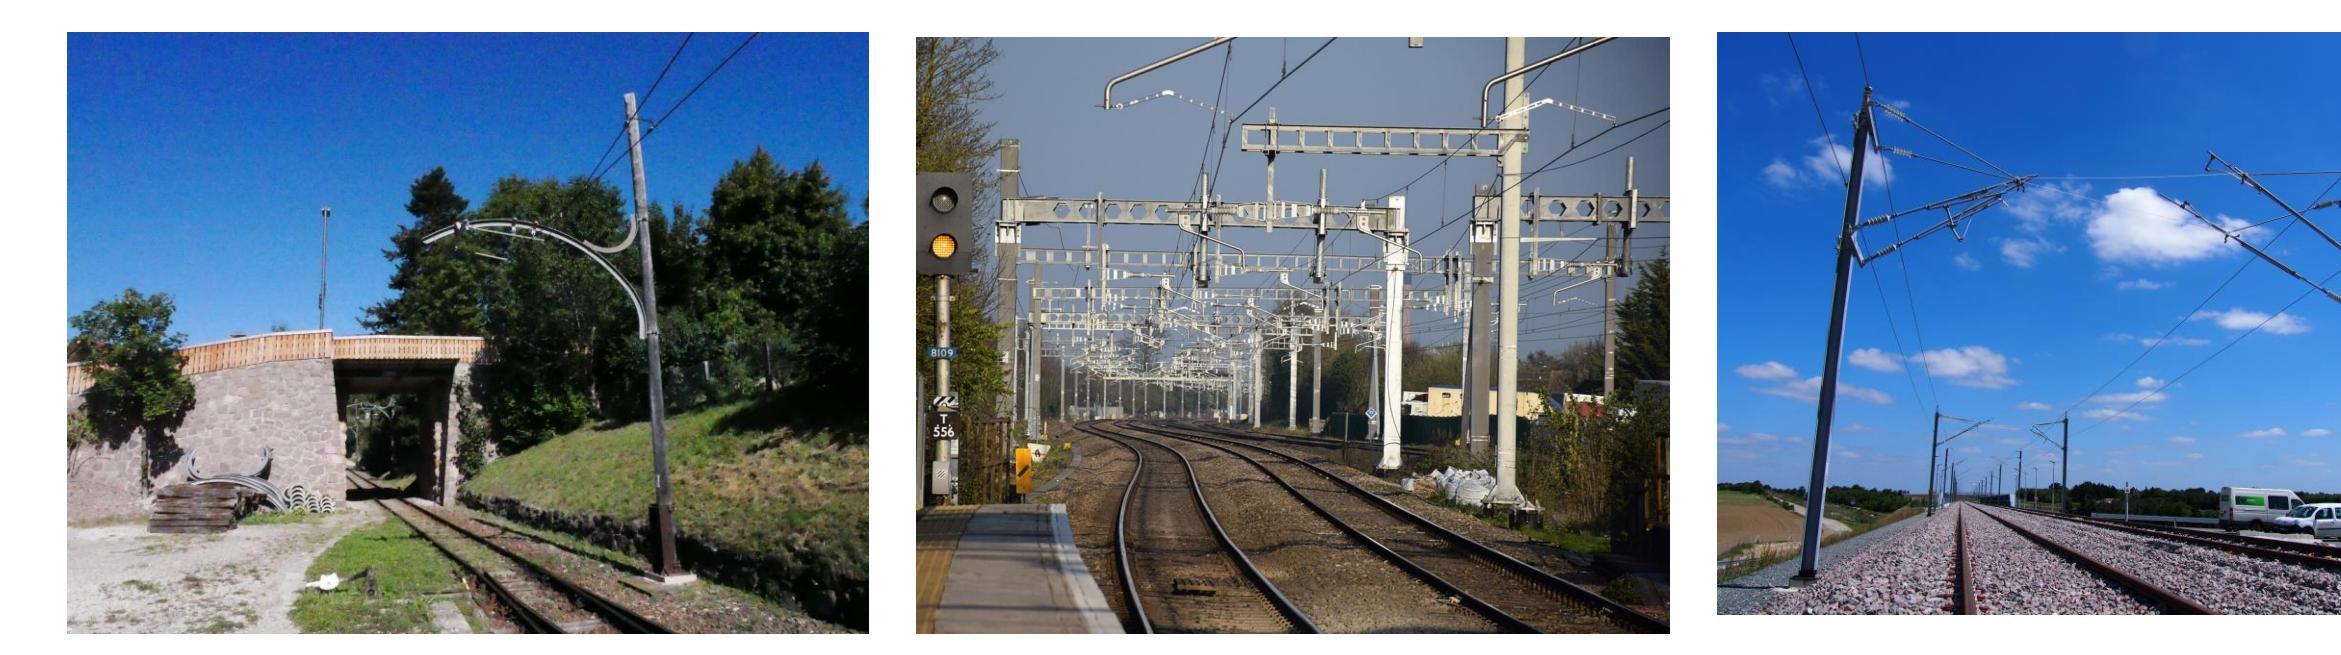
- Used on all types of systems:
  - 30 kph light rail (750v DC)
  - 100 kph metro generally third rail (750v DC)
  - 200 kph heavy rail (25kv AC)
  - 320 kph high speed rail (25kv AC)

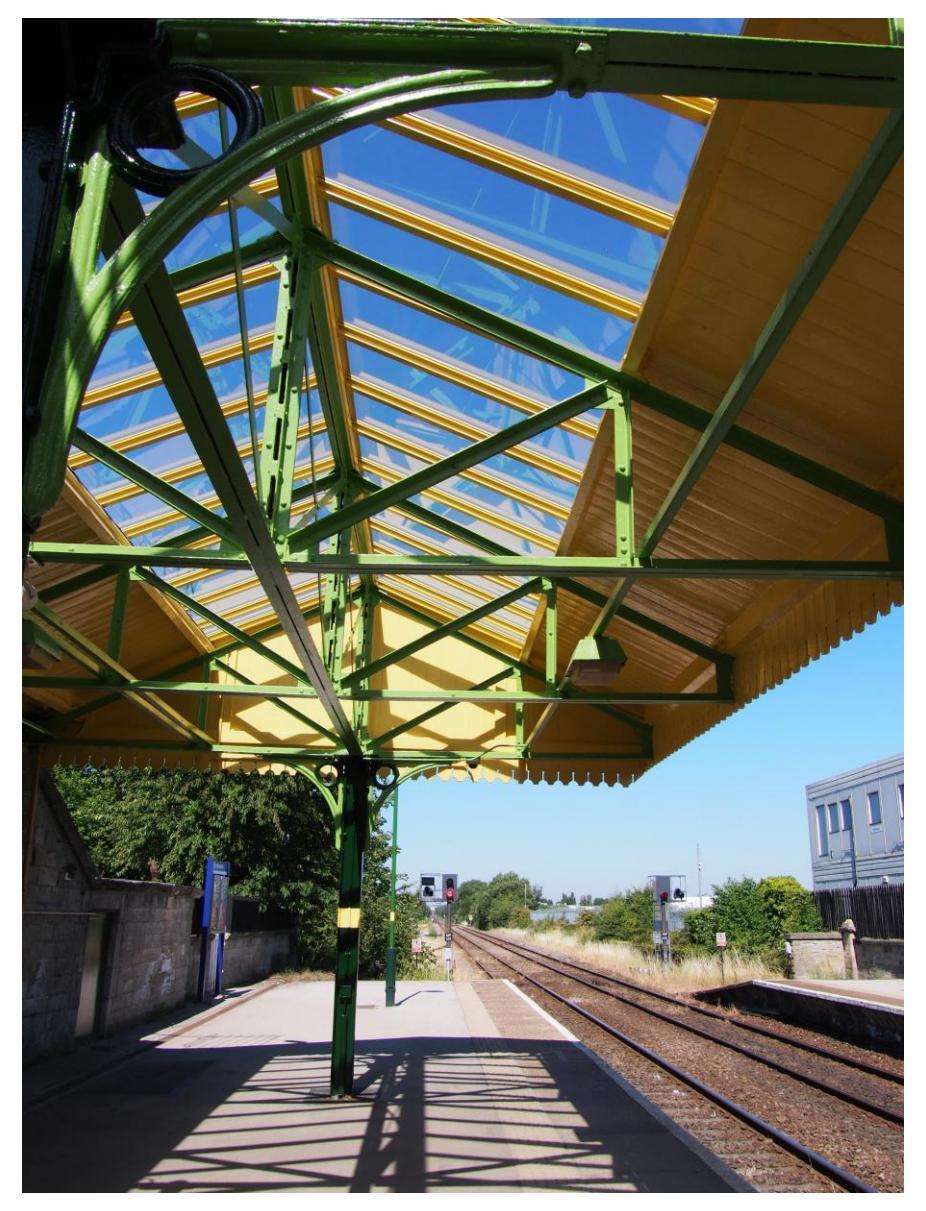
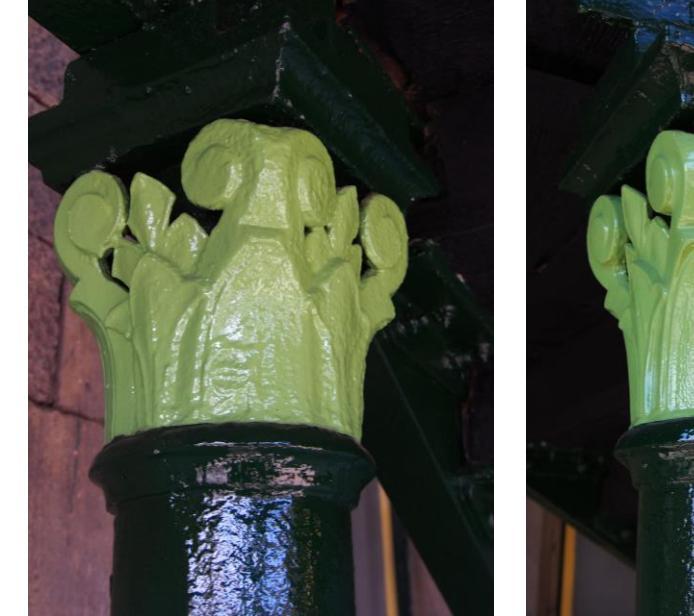
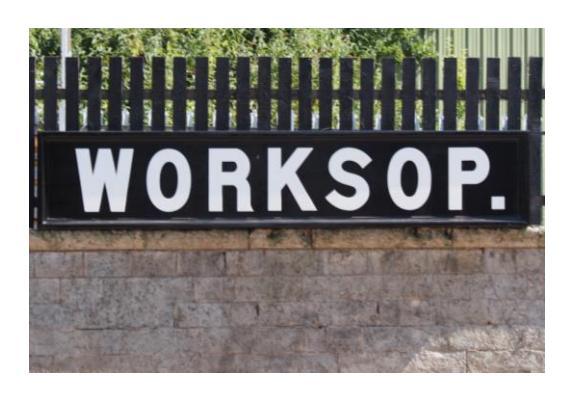
# Case Study: Worksop Station Refurb

- Work by Network Rail and "Commercial & Marine"
- Refurbishment of station, dating from 1849
- Historic livery from the LNER era (1930s)
- Original station features recreated from scratch
- Category winner at the National Rail Heritage Awards (NRHA)

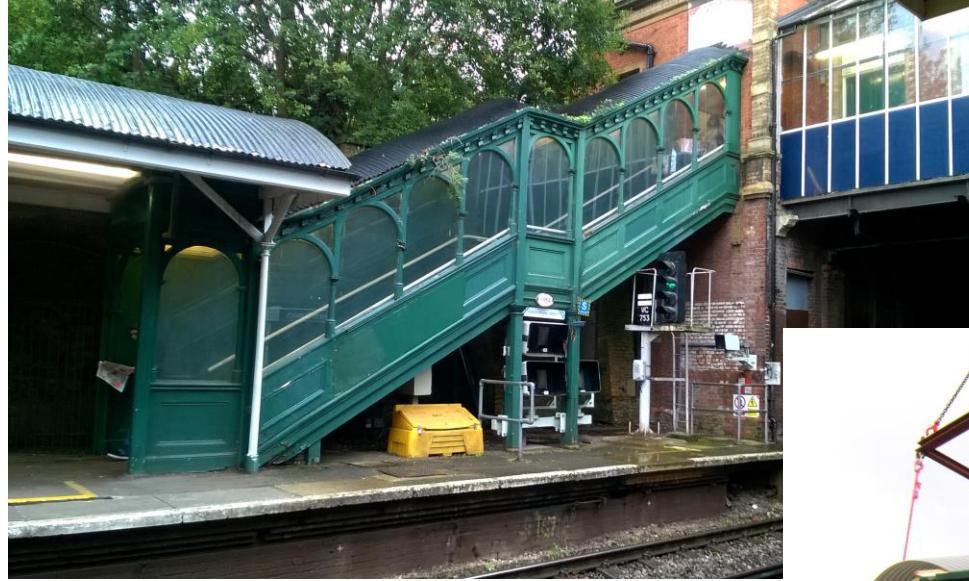
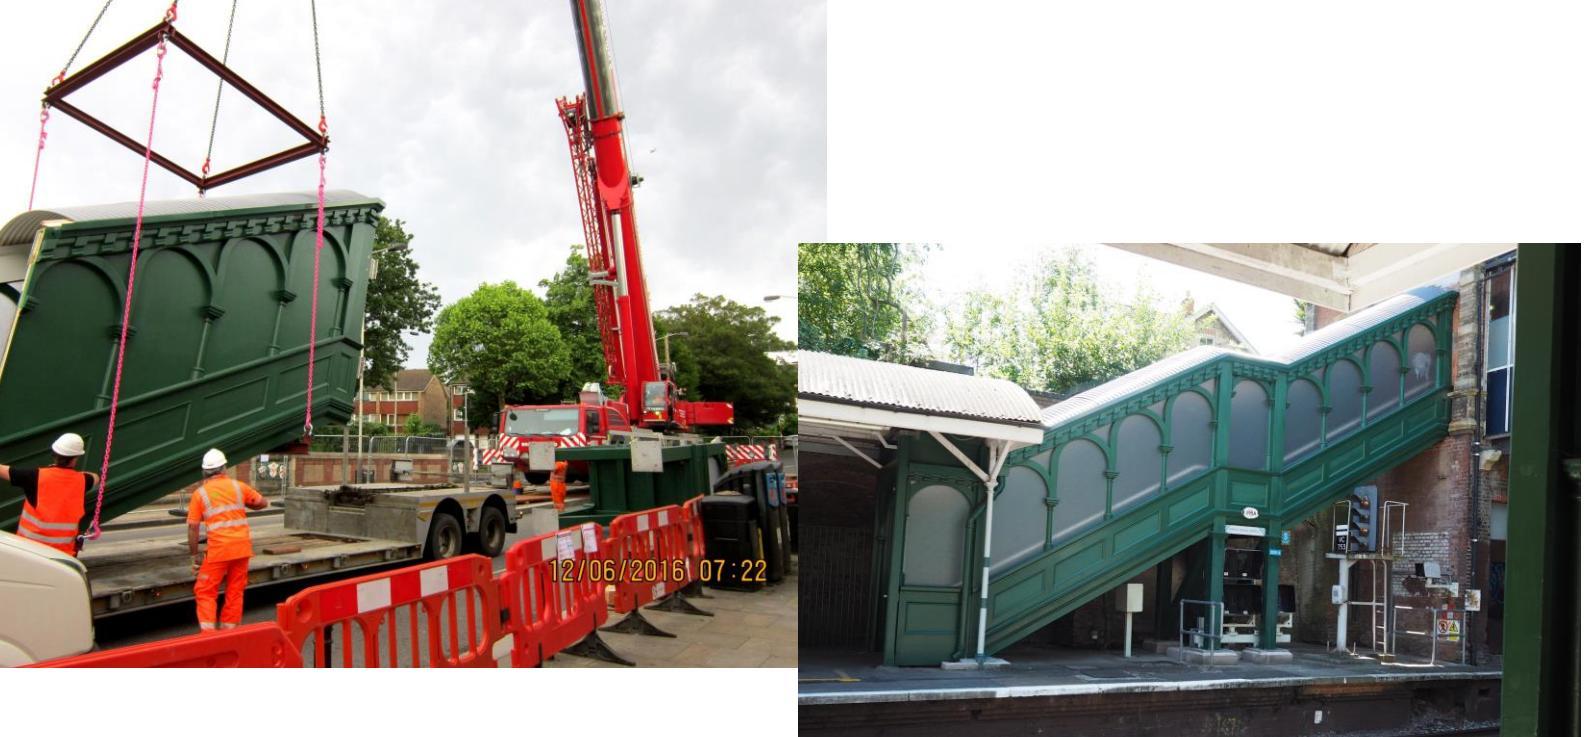
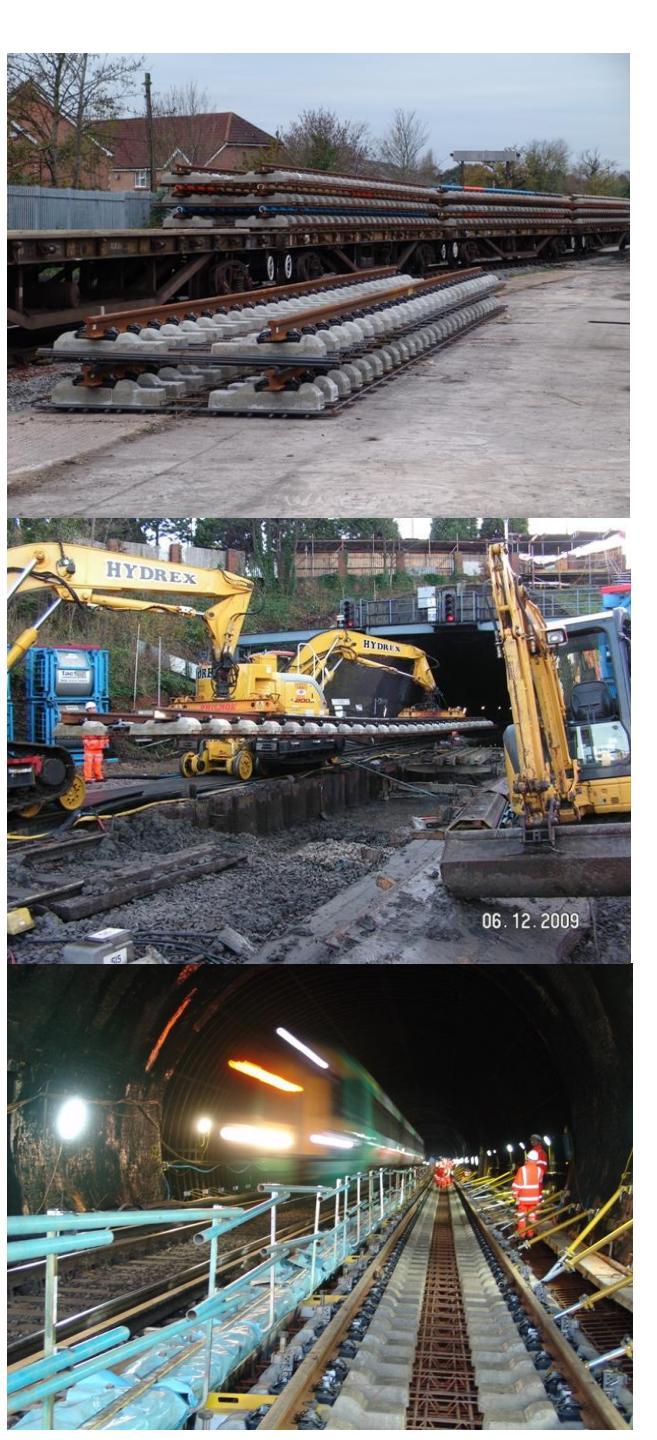
# Case Study: Dulwich staircases

- Work by Network Rail / BAM
- Existing stairs were suffering from "wet rot" and needed replacement

- New stairs manufactured, off site, from Accoya timber
- Worked with local conservation officer

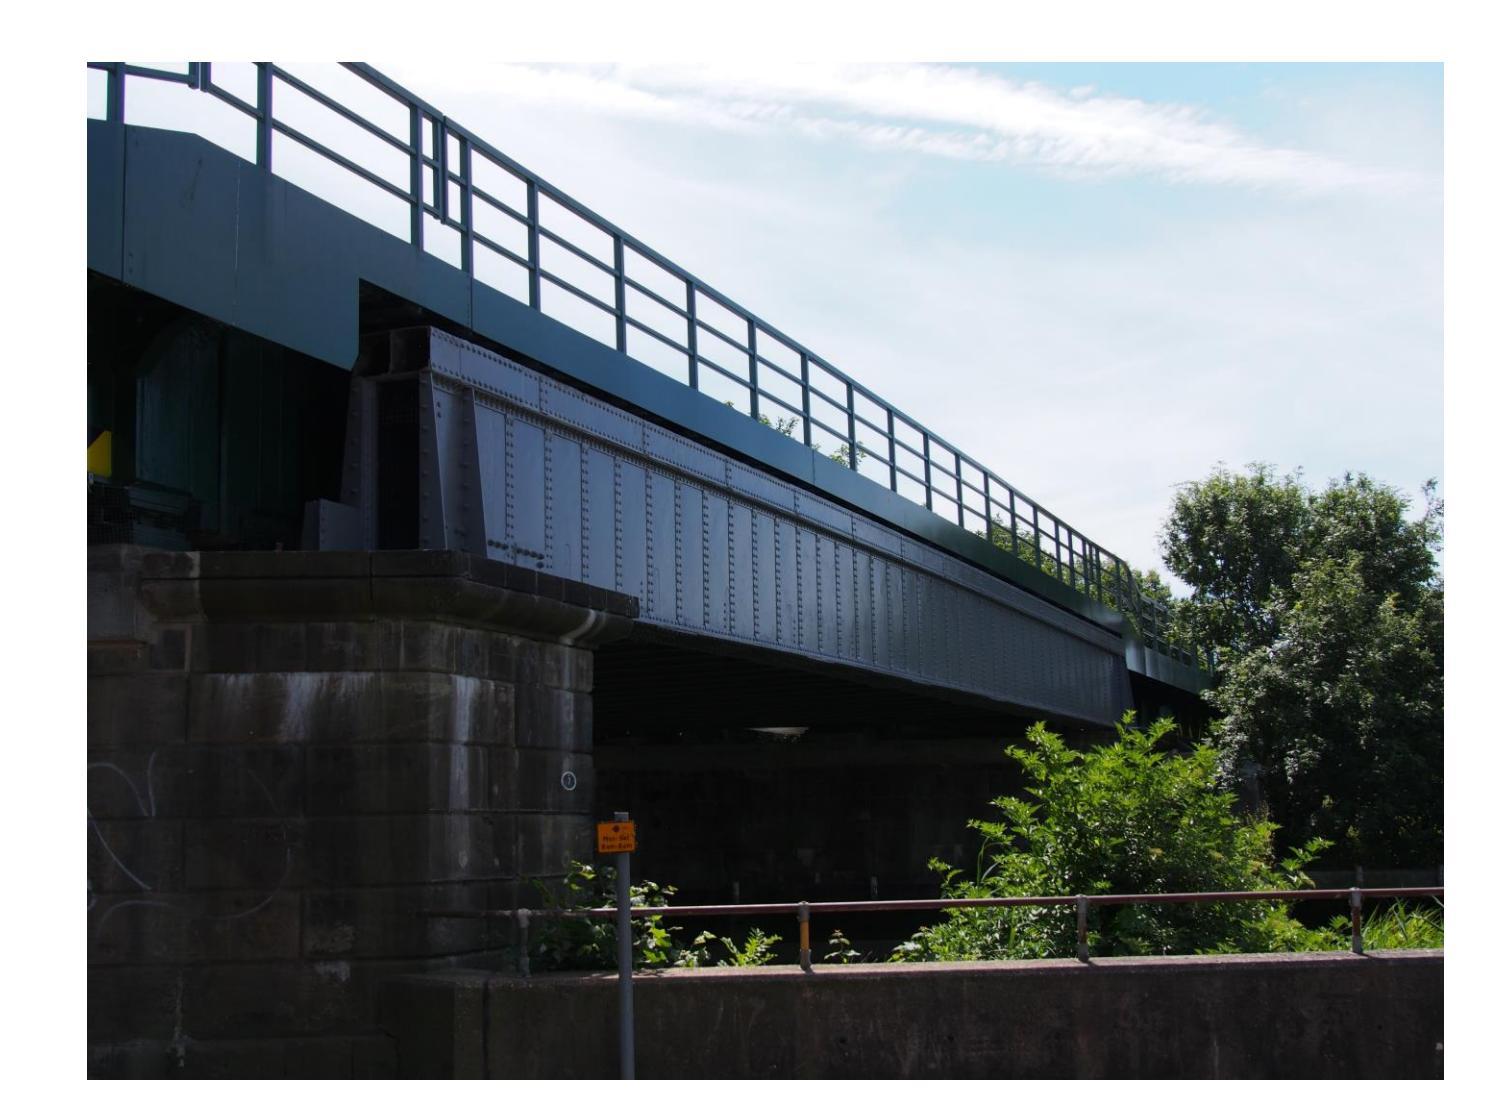
# Case Study: Lincoln – River Witham Bridge

- Work by Network Rail / AMCO
- The River Witham Bridge was built in 1848 and used the Fairbairn tubular box edge girder system for the main span, over the river
- Important route, to Immingham, carries a lot of freight trains
- The new structure uses the existing piers together with a "standard" composite steel / concrete prefabricated deck unit
- They were able to reposition the, refurbished, original box girders either side of the new deck
- Commended at the NRHA

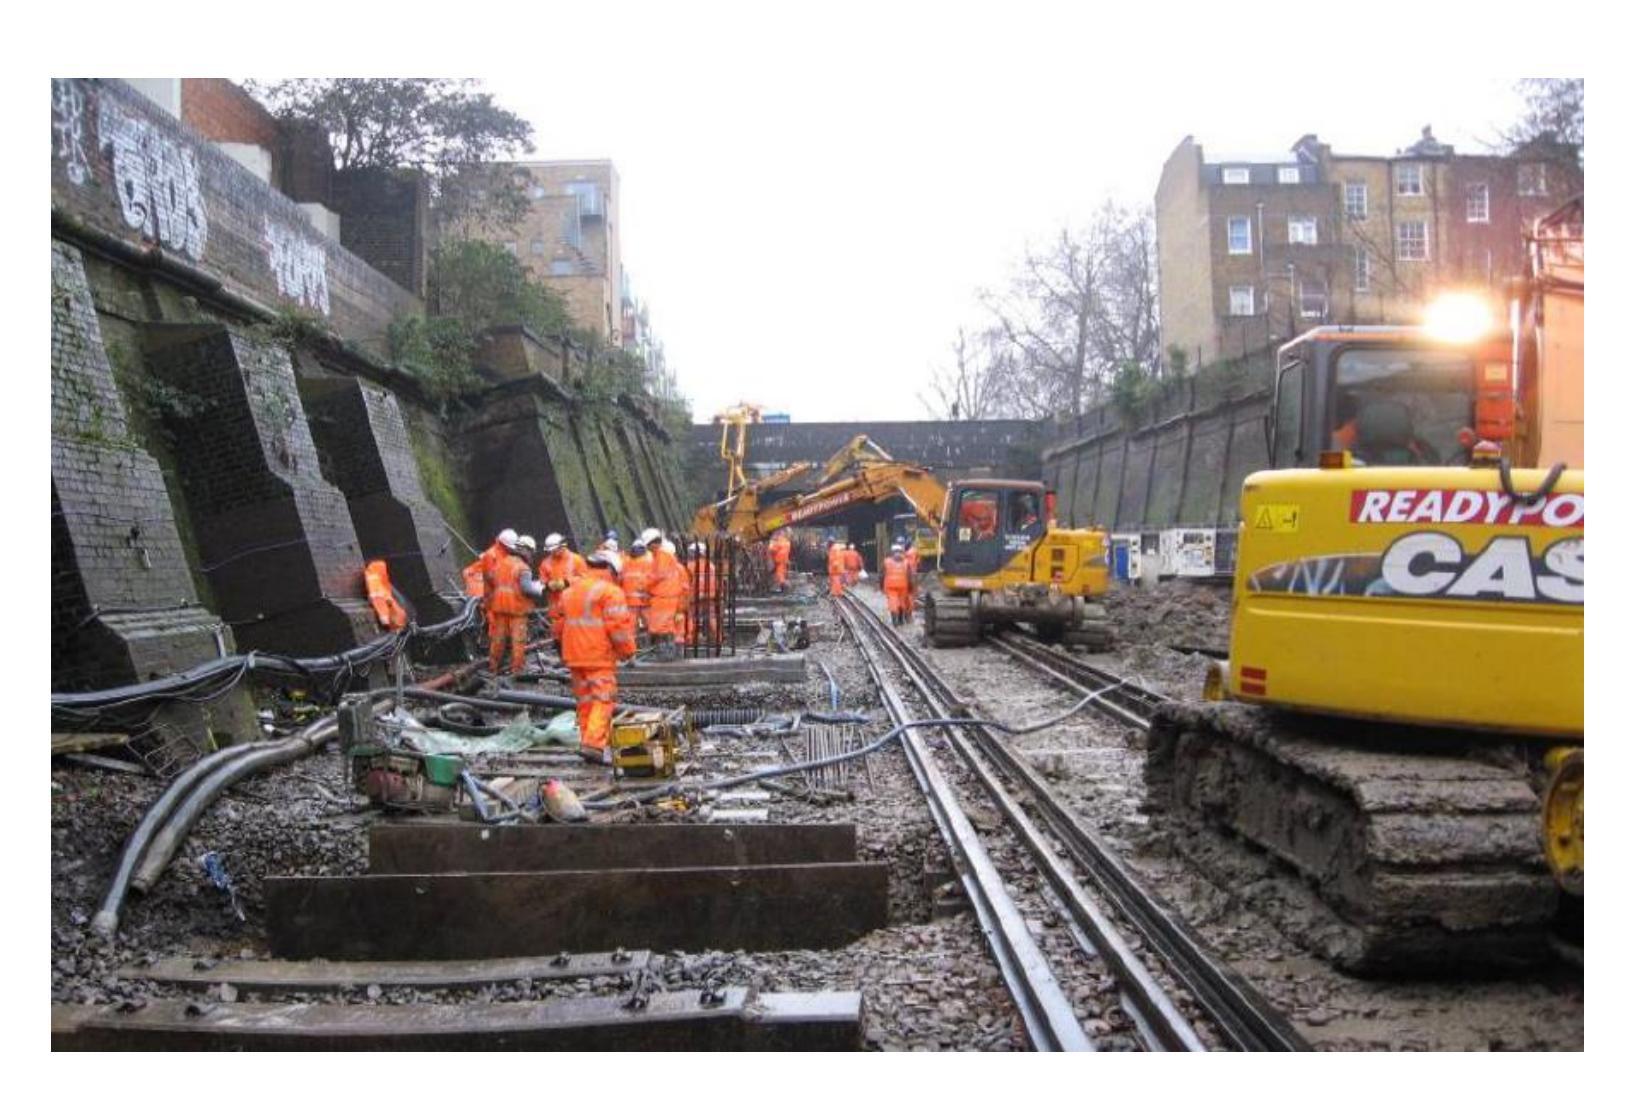
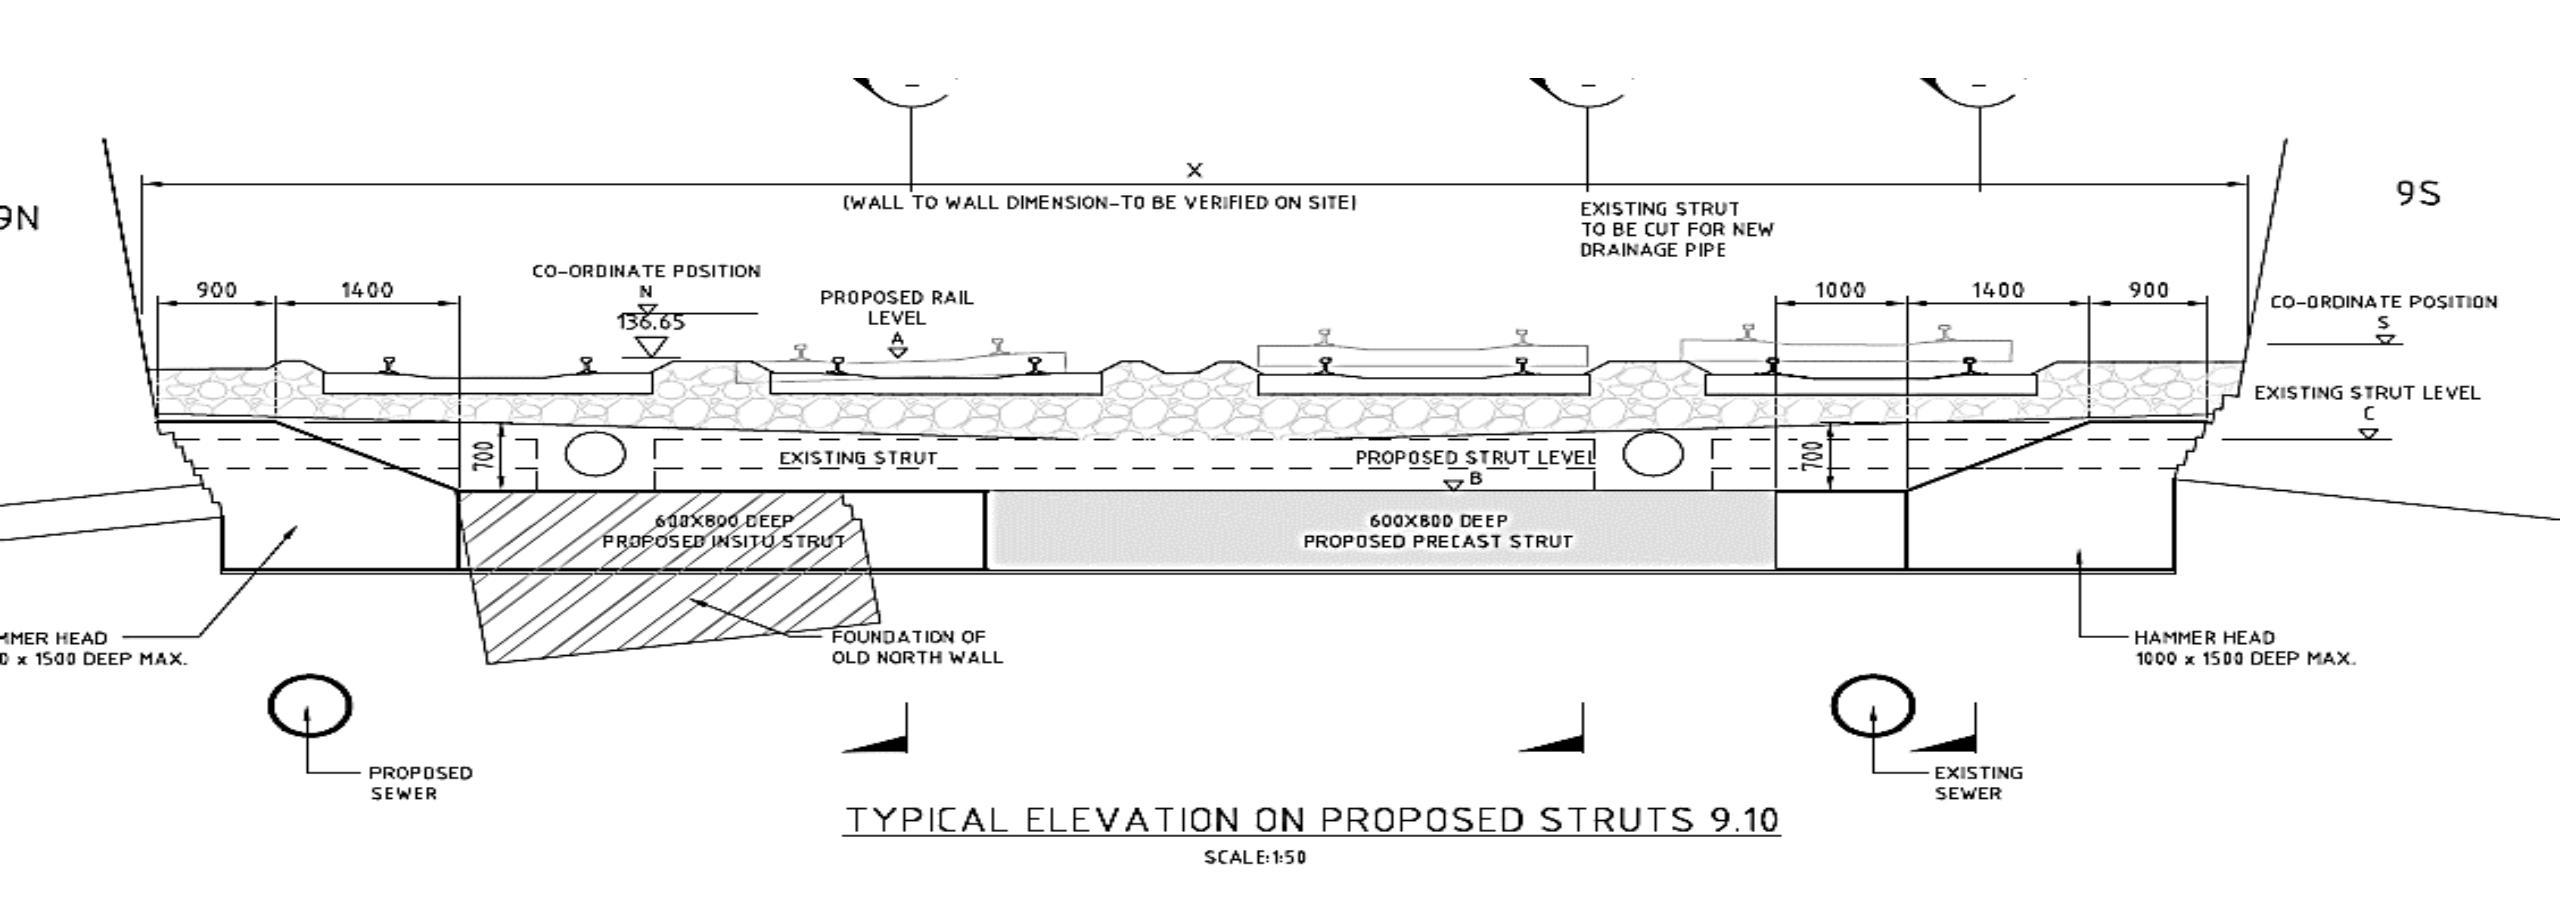
# Case Study: North London Line - 1

- Work by Network Rail & Carillion
- Railway in artificial "canyon" opened in the 1850s
- Unstable walls & leaking sewer
- Upgraded to four tracks with overhead line
- Needed increased headroom – so lowered track, but:
